Fiat X1/9

Neat styling, superb handling and potentially loads of rust, the Fiat X1/9 has them all. Kim Henson takes a close look at this Italian sports car.

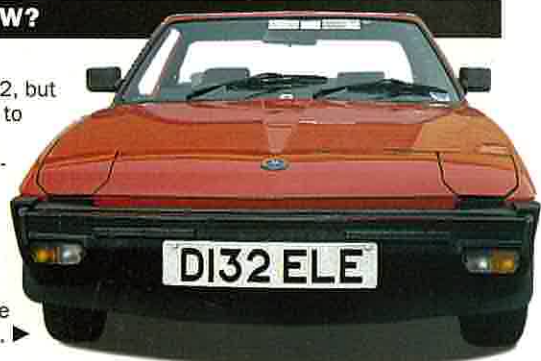
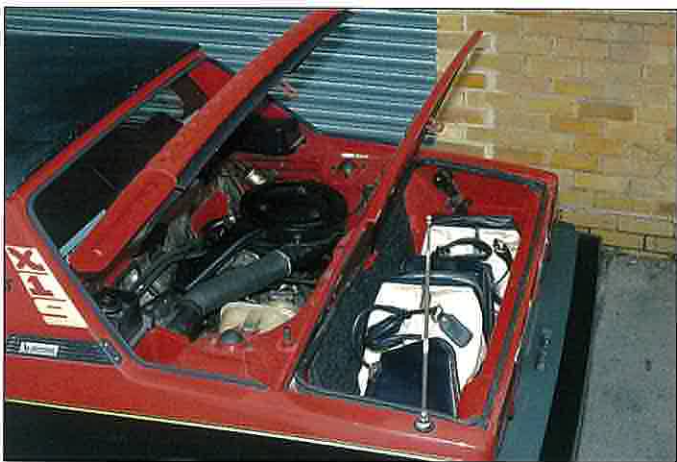
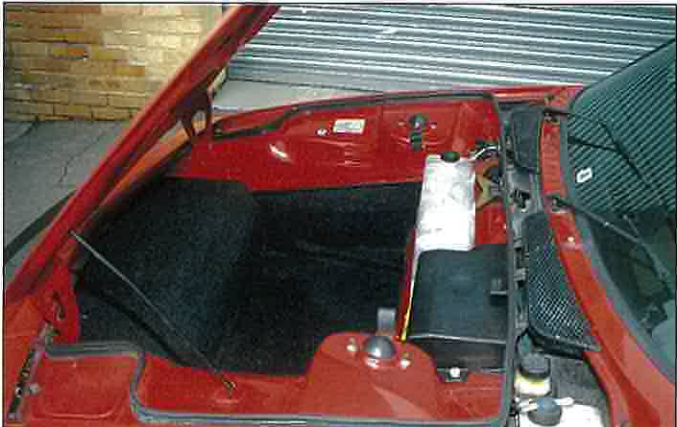
Above: Two compartments in rear, engine then small boot
Below: Car boasts useful extra luggage compartment up front.

All X1/9s are remarkably practical cars for real life motoring, and feature a pair of luggage compartments – there's a long, wide and shallow one in the nose of the car, plus another wide, if not very deep, 'boot' located at the rear, just behind the engine. On those rare occasions when the sun comes out the Targa panel can be removed and stowed in the rear luggage compartment.

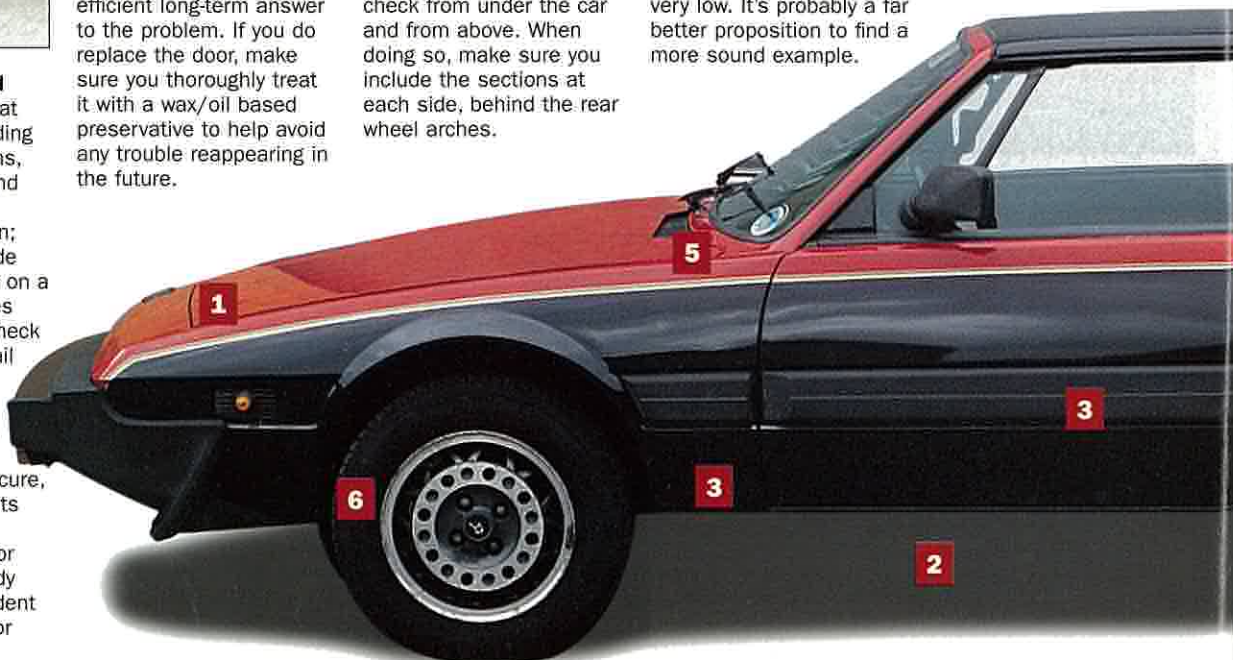
BODY & CHASSIS

Neglected cars need very careful checking as rust likely to be rampant

1 Check front end of body shell. Open the lid of the forward luggage compartment and inspect the structural metalwork thoroughly. Pay special attention to the sections beneath the front chassis legs, usually hidden beneath the floor mat, and areas around the hinge mountings. Look closely too at the suspension turret tops. Check the inner and outer wings and the nosecone. Although neglected X1/9s can be very rusty, a well cared-for example can survive long-term. Even cars which appear superficially rusty in several places can be sound in key, structurally important areas.

2 Examine sills and underbody. Look at sill assemblies, including top, horizontal sections, adjacent floor pans and jacking points. Damp carpets are a bad sign; rainwater leaks corrode the floor. With the car on a ramp, check structures behind the wheels. Check along each chassis rail and panelwork between them and the front cross-beam. Ensure that the tie rod mountings are secure, also the location points for all suspension components. Watch for distortion of underbody (due to possible accident damage) as well as for corrosion damage.

3 Check front wing extremities. The lower rear corners of the front wings can rust away; scrutinise them closely for any holes and for the tell-tale signs of trouble – extensive dollops of body filler. If corrosion is serious, it can extend to surrounding structures, so make sure you view these carefully. The lower edges of the doors can suffer from rust damage too; the first signs are bubbling along the bottom of the outer skin. Open each door fully and examine carefully the bottom section from underneath in addition to viewing from the side; in severe cases the lower edge of the door may be virtually non-existent. Effective repairs will involve welding in new steel, and are therefore complex and time-consuming; often a replacement door is the easiest and most cost-efficient long-term answer to the problem. If you do replace the door, make sure you thoroughly treat it with a wax/oil based preservative to help avoid any trouble reappearing in the future.

4 Examine the rear valance. Due to the lowdown stance of the X1/9, it is much easier to view the rear valance and its associated panelwork with the vehicle raised on a ramp. This will make the examination of the underside of the engine and transmission, covered elsewhere, an easier prospect. Ensure that the valance is not in an advanced state of disintegration. However if it is crumbling away this is not necessarily a reason to reject the car as replacement panels are available for under £50. While in this area, check out the state of the exhaust system; a new system can currently be obtained for just over £100. Look closely too around the rear wheel arch lips, and at the state of the metalwork which forms the floor of the rear luggage compartment; check from under the car and from above. When doing so, make sure you include the sections at each side, behind the rear wheel arches.

5 Look closely at deck panel ahead of windscreen. Severe rust in the panel immediately ahead of and beneath the windscreen, and also in the screen pillars (A-posts), is a cause for concern, as neat, strong repairs here are not at all easy to execute. In any event the windscreen will need to be removed in order to tackle such work. If the steel has already been breached, be prepared to discover damage which is far worse than is immediately apparent. Often, once you make a detailed investigation, it will be found the rust has spread far and wide beneath the paint, and may have affected a large area. As a general point, if the car you are viewing proves to be seriously rusty, only consider parting with your cash if you love a challenge and the price is very low. It's probably a far better proposition to find a more sound example.

6 Assess wheels and body trims. If the structure and exterior bodywork panels have passed a detailed inspection without revealing too many horrors, walk around the car and focus on other aspects, including the wheels. Styles vary according to model, but, regardless of which type are fitted to the example you are viewing, it is important that they are in good condition, as 'correct' replacements may be difficult/expensive to source. Corrosion of the alloy rims is common; look closely if the metal appears to have suffered from serious erosion. The bumpers and unique-to-version badges and decals need to present, correct and in tidy condition. Ensure too that the headlamps rise and fall on demand, are sound and fully operational.

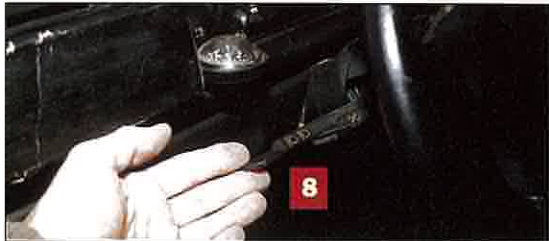
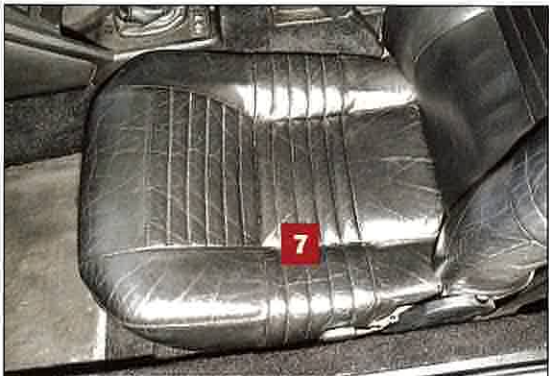
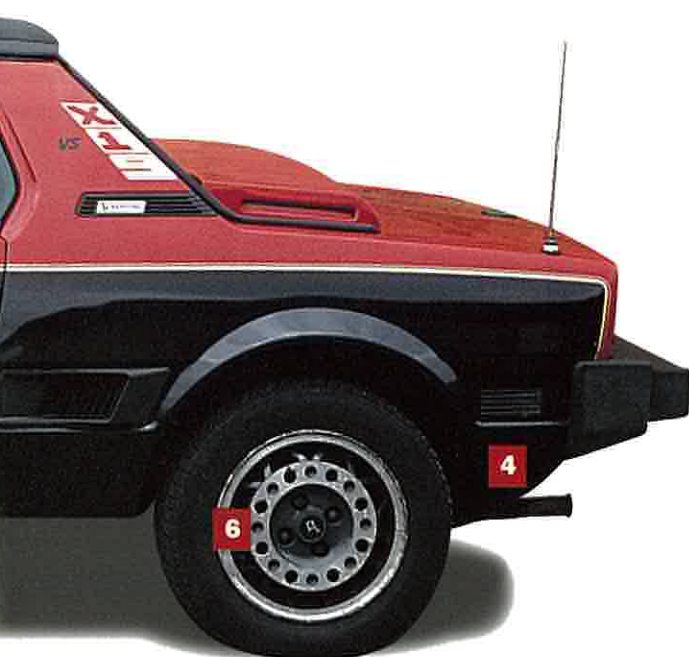
INTERIOR

Seats suffer seam damage

7 Scrutinise seat coverings. Depending on the model, you may find cloth or leather-covered seat coverings. The cloth versions can suffer from wear, especially in the outer bolster on the driver's side, and splitting seams. The leather seats are prone to seam damage, also brittleness. Applying of hide food is advised to keep them looking good.

8 Other interior checks. Check carpets and door trim panels for damage, and ensure that all instrumentation and switchgear works as designed. Stalk switches (with constant live feed) for headlamps and indicators are prone to burning out on late cars, but new switches are available. All trim components are scarce.

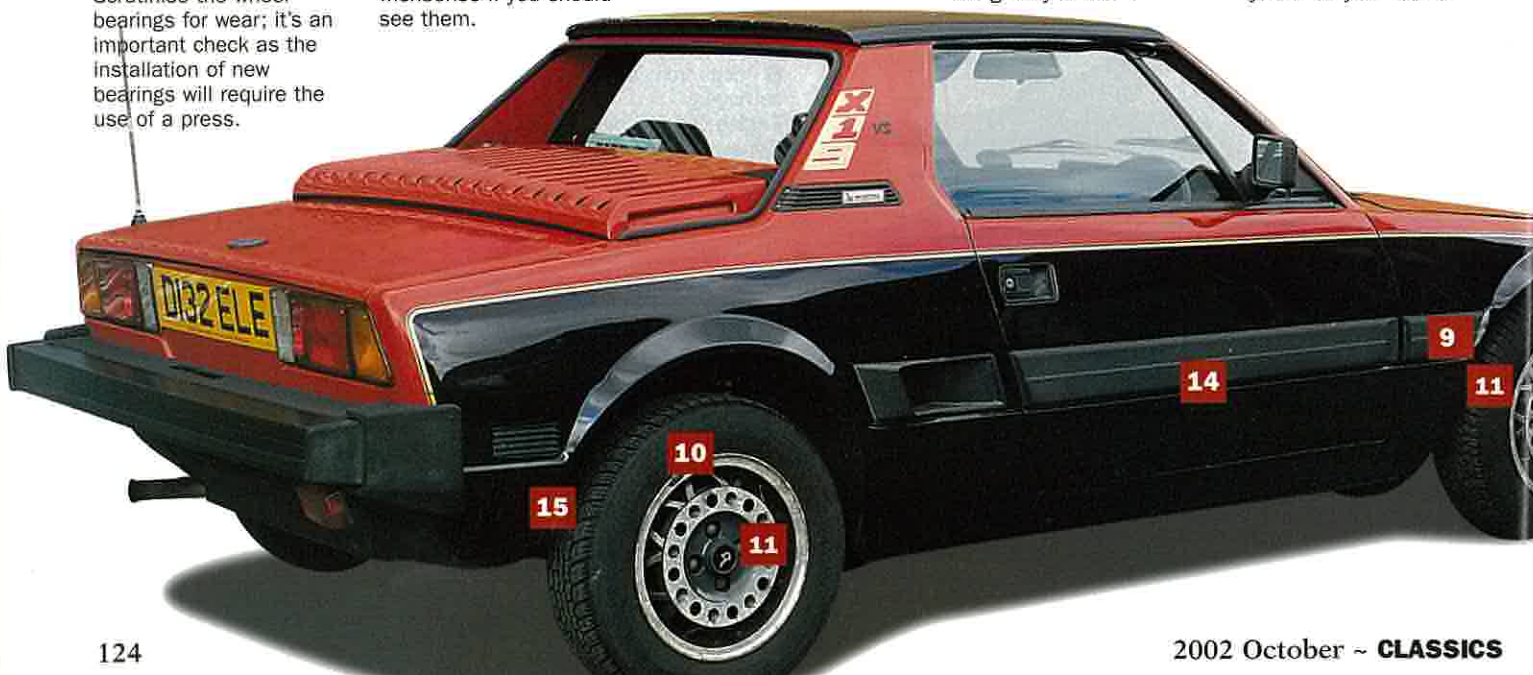
Brakes can seize on seldom-used X1/9s

High-revving five are lively, tough

The X1/9's strut-type front suspension is normally durable and effective, unless the coil springs are damaged or – rather more likely – the dampers are leaking. Make sure you check for both these ailments. Wear in the swivel joints and track rod ends eventually results in an MOT test failure. Note that the top strut bushes can wear as well. Meanwhile the front tie bar bushes crack as their age and mileage builds, and the lower suspension arm bushes also need to be checked closely. The rack and pinion steering system is normally very precise in action, but becomes more vague as the rack wears. Inspect the rack gaiters through the underbody apertures; if any leaks are discovered the gaiters should be renewed before the water and grit can enter and cause damage. Scrutinise the wheel bearings for wear; it's an important check as the installation of new bearings will require the use of a press.

The X1/9's independent rear suspension gives exemplary ride and handling – provided all its components are in good condition. Examine coil spring/damper struts for damage and leaks, and check mounting bushes. Ensure wheel bearings are not badly worn – with each wheel raised in turn and rotated, listen and feel for graunching/excess free movement. The lower wishbone ball joints wear in time – MOT test failure follows. Unfortunately replacement ball joints are only supplied together with wishbones; these are scarce and expensive when new – more than £300 each!; however, secondhand wishbone assemblies can get you out of trouble for a smaller outlay. As there are no lubrication points there is not a lot you can do to prevent the wear, but it might be worth buying wishbones if you should see them.

The all-disc system works fine if regularly maintained, which involves ensuring that the sliding calipers are free to move. The brakes tend to seize if the car is used infrequently. The handbrake operating mechanisms are particularly prone to seizure, unless regularly stripped/cleaned and lubricated with graphite grease. Trouble is, few X1/9s are lucky enough to get such attention until an MOT test failure certificate is received... View general state of brakes from under vehicle, and assess handbrake effectiveness on a gradient, during your test drive. Julian Vernon of specialists Xtra X1/9s recommends checking the brakes every three to six months, adding that regular steam cleaning of the underbody/wheel arches helps to keep dirt and salt away from the brakes as well as the car's general structure.

Renowned for their strength and longevity, the overhead cam engines in the X1/9s are also lively, and economical in terms of fuel consumption, unless the standard twin choke Weber carburettor has ailing butterfly spindles or accelerator pump diaphragms. The carburettor can be overhauled for around £30 to restore lost power and economy. It is essential that the cam belt is renewed at least every 30,000 miles; check service record, if available, and enquire of owner when belt was last changed. Power output and crankcase pressure are adversely affected by blockage of the crankcase breather valve (easily cleaned in de-greasing fluid). Very high mileage engines may show signs of worn piston rings and bearings, but these units are capable of clocking up well over 150,000 miles, if regularly serviced.

Coolant flows between the front-mounted radiator and the mid-mounted engine (and back again) via underfloor-mounted steel pipes which eventually can corrode, resulting in a loss of water and potential overheating problems. If damage is localised, short sections of pipe can be replaced using rubber hoses. However, if corrosion is more serious, full replacement of the pipes will need to be carried out and this is a major operation. Check also the state of the radiator core, which is visible with the aid of an inspection lamp from under the front of the car, and also look at the rubber hoses and the cooling fan. During your test drive, keep a close eye on the temperature gauge... It is vital that antifreeze mixture with corrosion inhibitors is used in the cooling system all year round.
